LAKE HOLLENBECK DAM
CAPE GIRARDEAU COUNTY, MISSOURI

MISSOURI INVENTORY NO. 40050

PHASE I INSPECTION REPORT
NATIONAL DAM SAFETY PROGRAM

NOVEMBER, 1978

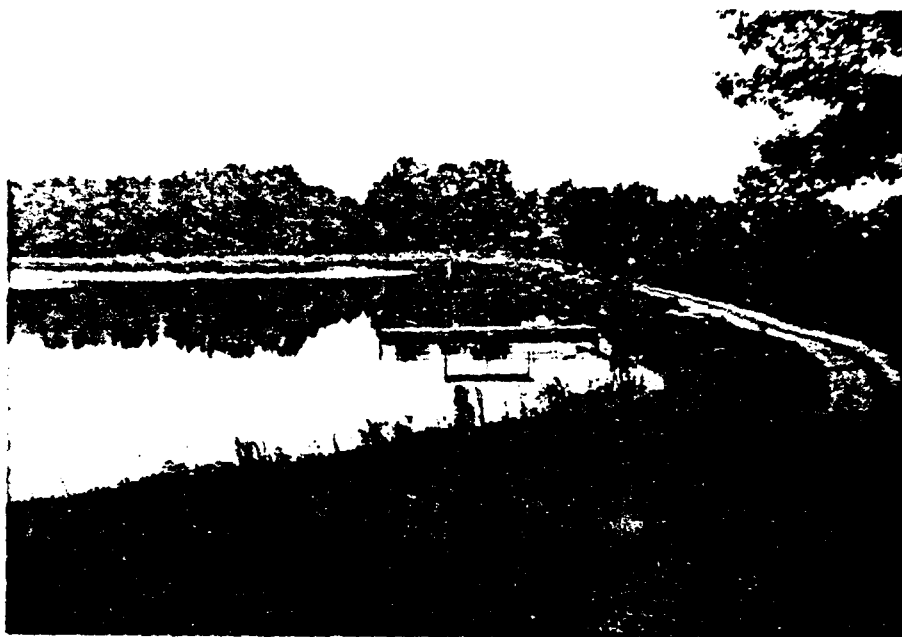
PHOTO 1 Overview of Lake and Dam

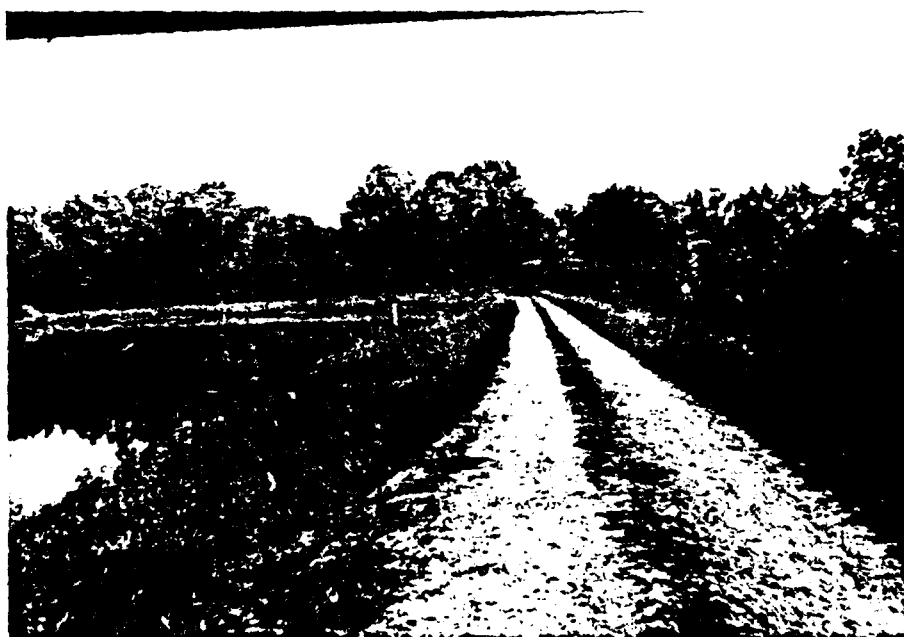
PHOTO 2 Crest of Dam

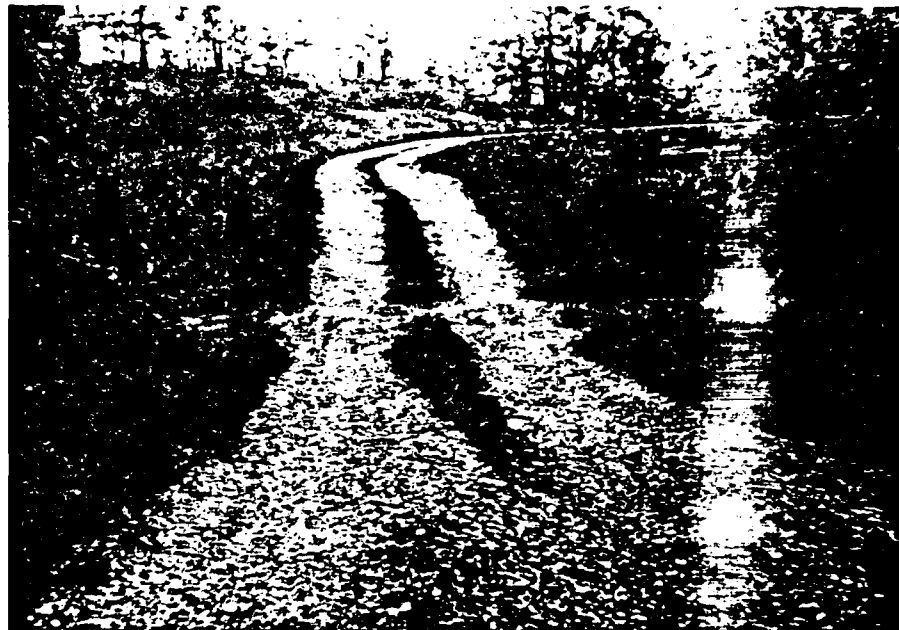
(2) The emergency overflow spillway is located on the north side of the lake and its discharge presents no problem to the dam's integrity.

PHOTO 5 View of Emergency Spillway
